Gaggia Anima

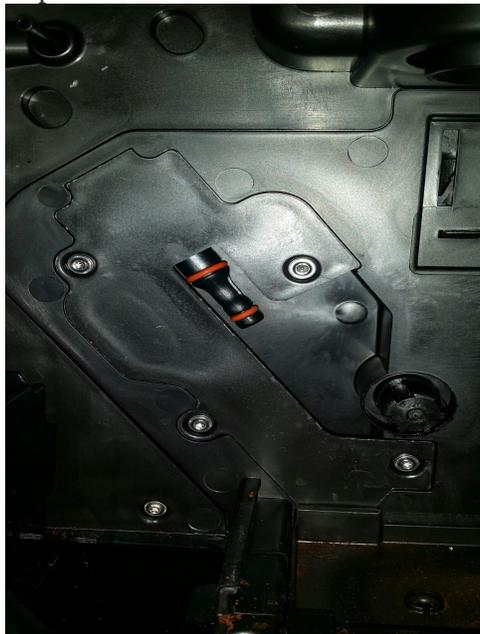
You should see 4 silver screws in a panel that looks like this:

Remove the four screws using a 2 mm allen key.

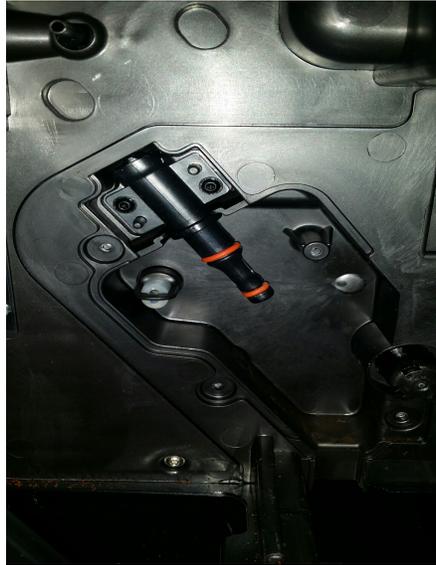
You should now see this:

You should now see two black screws. Remove these using the same allen key. Remove the entire spout. Be careful, as there are 2 red o rings on the back side of this. If the o rings come off and remain in the machine, use the allen key to hook them, and remove them from the machine. The spout should look like this:

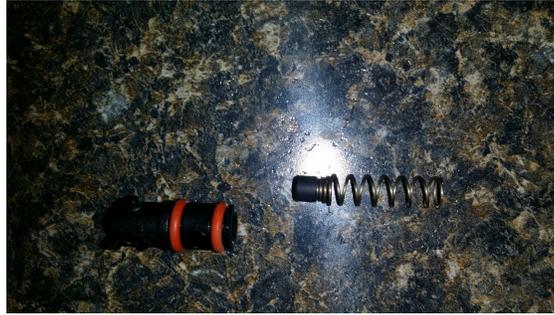
Next, get a flat head screwdriver, and unscrew the boiler spout top. You'll see two little pegs that need to align to lift it out. I had to push this top part off, by pressing on it from below, using the screwdriver. Once this is apart, you will see a little black rubber stopper and a spring. It should look like this:

The little black plug you see in the photo is the cause of the squeak. As it moves back and forth from the water pressure, it rubs against the inside of a plastic chamber. You can use any food safe lubricant to apply a thin layer of grease to this, but if you have the tube of brew unit grease that comes with most new machines, this would be recommended.
